# Manhole Inspection Summary

Manhole # S33KK\_005MH

Insp Date: **12/6/06 12:44 PM**

**Location** Address: **1801 LAFAYETTE AVE**

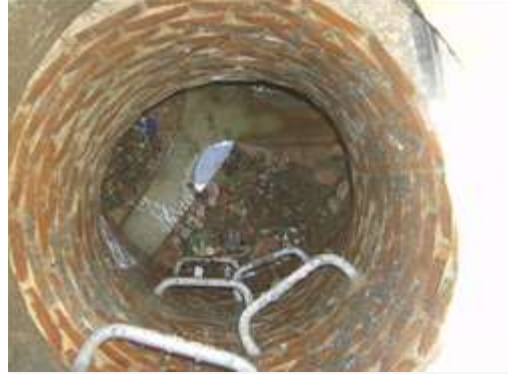
Top View

Evidence of surcharge - Bench debris.  
Channel debris.

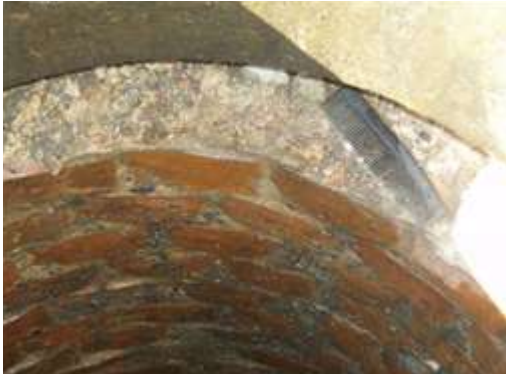
Defect

Frame leaks. Frame offset. Corbel  
deterioration and infiltration.

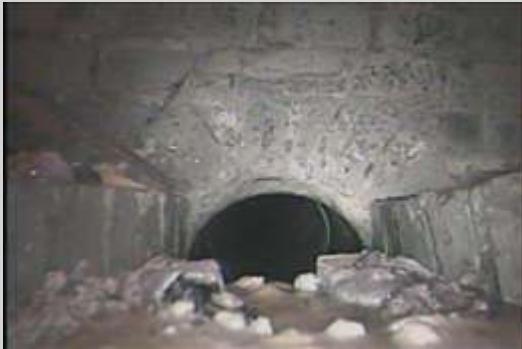
### 8 in. Circular Gravity Sewer Pipe Out @ 12 O'Clock

Deposits: ☐ None ☒ **Mud** ☐ Sludge ☒ **Debris** ☒ **Grease**

Silt Depth: **4** (in.) Deposits Extent: **Medium**

Infiltration: **Evidence** Pipe Seal Cond: **Unknown**

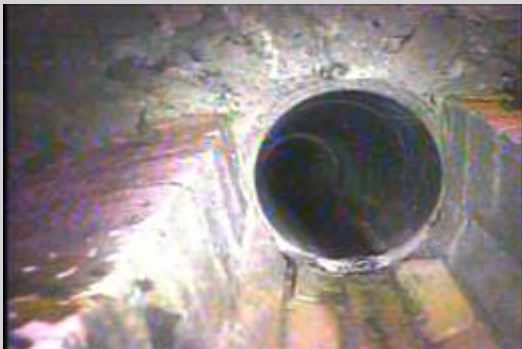
### 8 in. Circular Gravity Sewer Pipe In @ 3 O'Clock

Infiltration: **Evidence** Pipe Seal Cond: **Cracked**

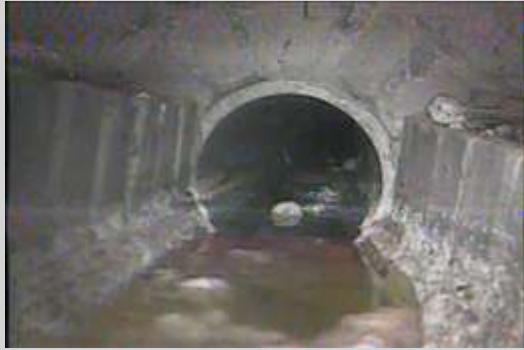
Pipe In @ 7 O'Clock

Deposits: ☐ None ☐ Mud ☐ Sludge ☒ **Debris** ☒ **Grease**

Deposits Extent: **Light**

Infiltration: **Evidence**
